### App Note 1015: W204 Factory iPod Connector issues

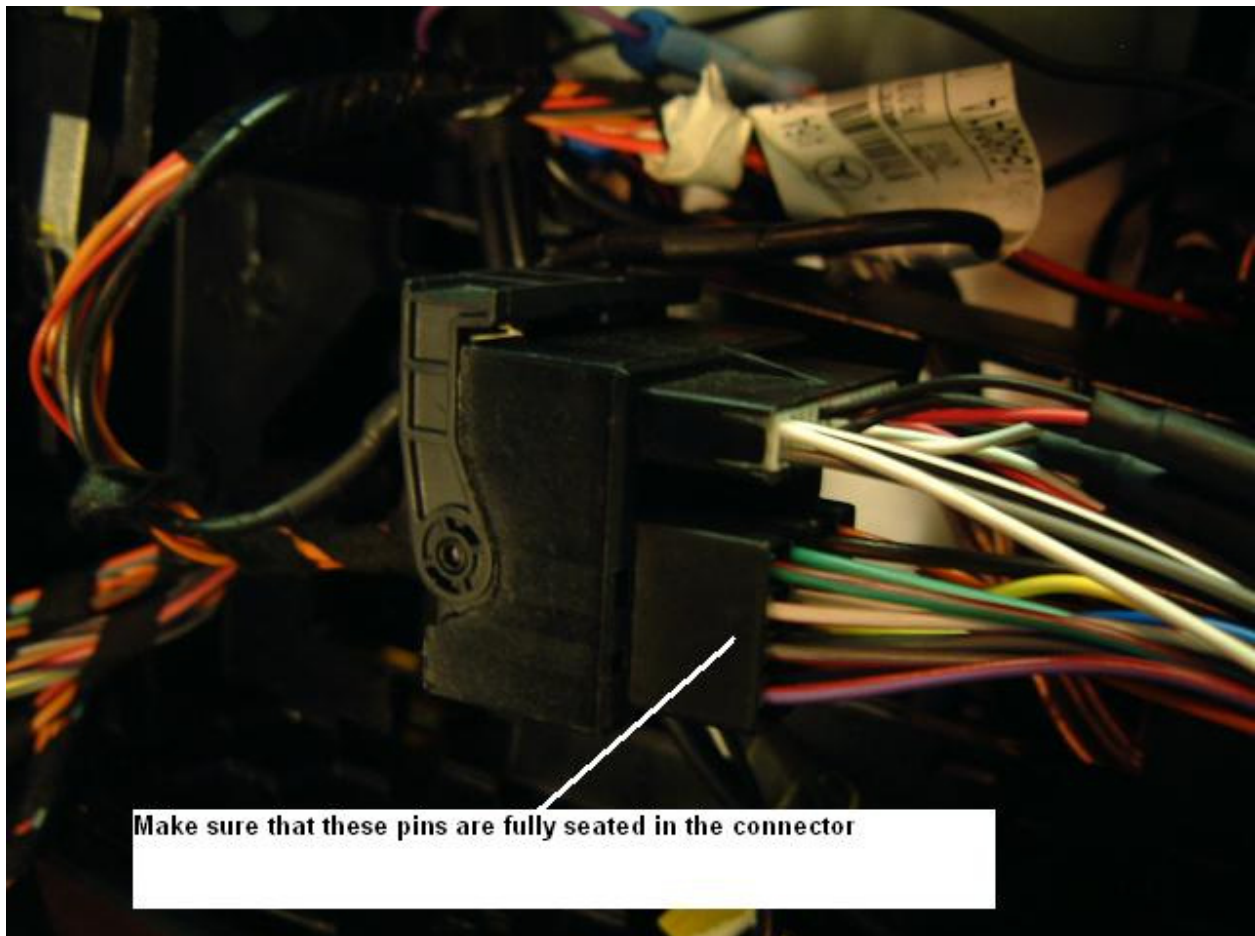
When installing the Video-In-Motion Module on the W204 with the factory ipod option there may be issues with the radio not turning on or with intermittent operation. This is often due to a problem with a defective factory ipod T-Harness. The issue lies in the receiver end of the harness (the end without the locking lever). Look at the connector once it is locked together with its mating connector and check that the connector pins have not become unseated. The ends of the pins should all sit at a uniform height.
